Manhole Inspection Summary

Manhole # S69S__022MH

Location Address: **6423 Danville Ave.**

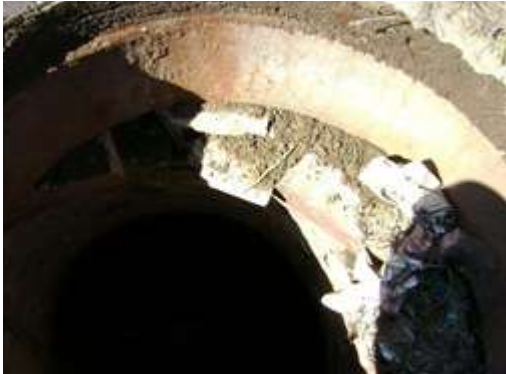
Defect 2

Condition: ☐ Sound ☐ Cracked ☐ Root Intrusion ☒ **Loose Brick** ☒ **Deteriorated**

Infiltration: ☐ None ☒ **Joint** ☐ Cracks ☒ **Mortar** ☐ Roots ☐ Wall

Deteriorating chimney

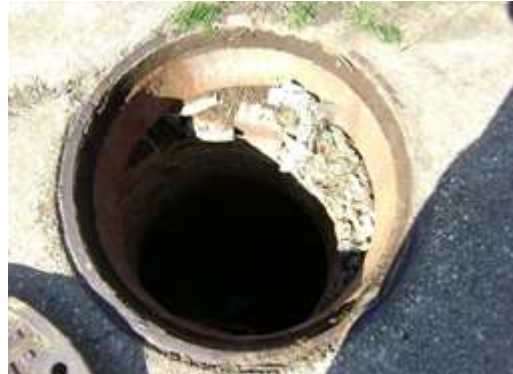
Defect 1

Frame Offset: **3** (in.) Condition: ☒ Sound ☐ Cracked ☐ Leaks

Frame offset

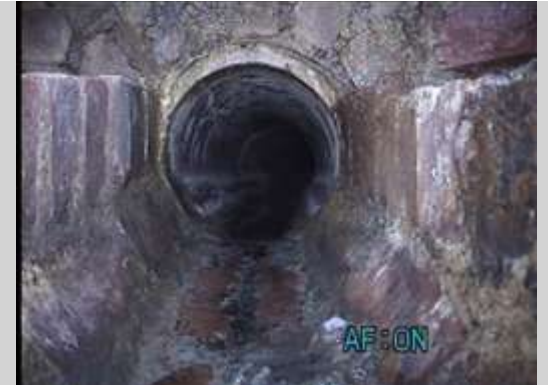
8 in. Circular Gravity Sewer
Pipe In @ 6 O'Clock

Pipe Height: **8.4** (in.) Rod and Bar (Angled)
Pipe Material: **Clay** ☐ Pipe Lined
Invert Depth: **8.67** (ft.) Flow Characteristics: **Slow**
Deposits: ☒ None ☐ Mud ☐ Sludge ☐ Debris ☐ Grease
Silt Depth: (in.) Deposits Extent:
Infiltration: **None** Pipe Seal Cond: **Sound**

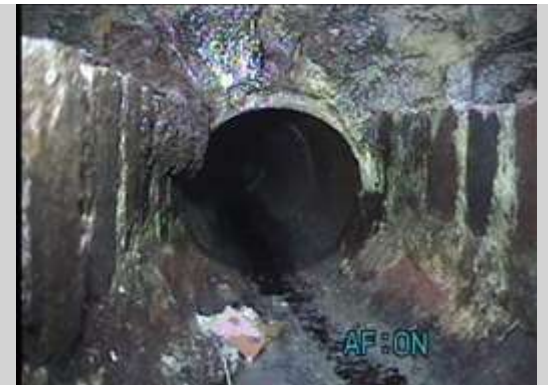
8 in. Circular Gravity Sewer
Pipe Out @ 12 O'Clock

Pipe Height: **8.4** (in.) Rod and Bar (Angled)
Pipe Material: **Clay** ☐ Pipe Lined
Invert Depth: **7.92** (ft.) Flow Characteristics: **Slow**
Deposits: ☒ None ☐ Mud ☐ Sludge ☐ Debris ☐ Grease
Silt Depth: (in.) Deposits Extent:
Infiltration: **None** Pipe Seal Cond: **Sound**
